Hints, Tips, and Frequently Asked
Questions for the xSeries 440

Quick Reference

Second Edition (October 2002)

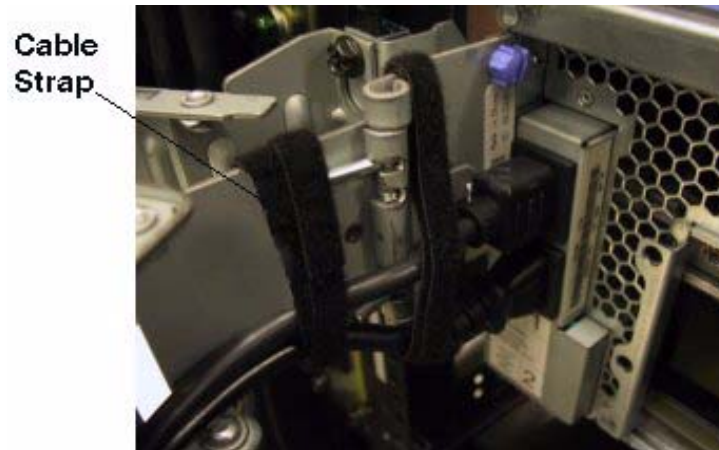
Ensure retention of main power cables

Description: When sliding the server in and out of the rack enclosure, the power cords might loosen or detach from the server.

Solution: In addition to the cable strap used to secure the power cords to the hinge plate (as stated in step 13 of the *Rack Installation Instructions*), install a cable strap around the power cords and the cable-management arm, directly behind the hinge that connects the arm to the hinge plate.

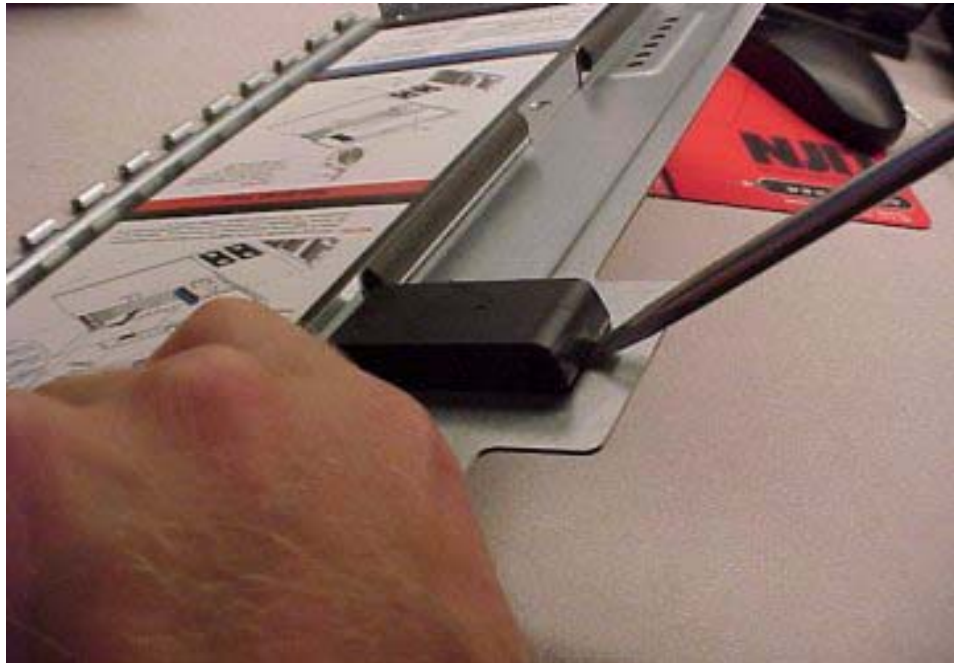
Top-cover latch difficult to use on servers manufactured prior to 6/14/02

Description: The top-cover latch on some xSeries 440 servers manufactured prior to June 14, 2002 are difficult to operate. Systems manufactured after 6/14/2002 are not affected.

Solution: Replace the cover latch. Order FRU part number 24P1289 for systems that have a chassis label dated 6/14/2002 or before.

Use a flat-blade screwdriver or similar tool to remove the existing top-cover latch; then, snap the replacement latch into place.

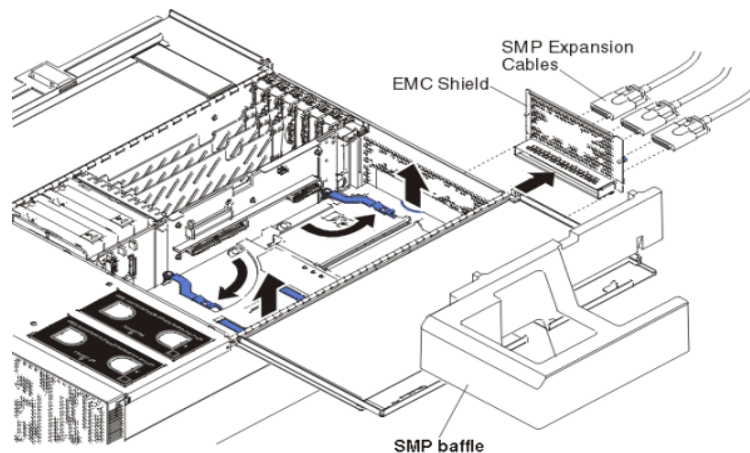
Removing an SMP Expansion Module

Description: You can damage capacitors on the centerplane if you are not careful when you install or remove an SMP Expansion Module (sometimes referred to as a CEC).

5. Loosen the blue thumbscrews holding the EMC shield to the back of the server; then, remove the EMC shield from the back of the server.

6. Grasp the two locking levers on the top of the SMP modules, and lift them up slightly.
7. Working from the right side of the server, rotate the two locking levers toward you until they are fully extended.
8. Being careful not to damage the components on the centerplane, use the handle and the finger relief on the SMP Expansion Module cover to lift the SMP Expansion Module out of the server.

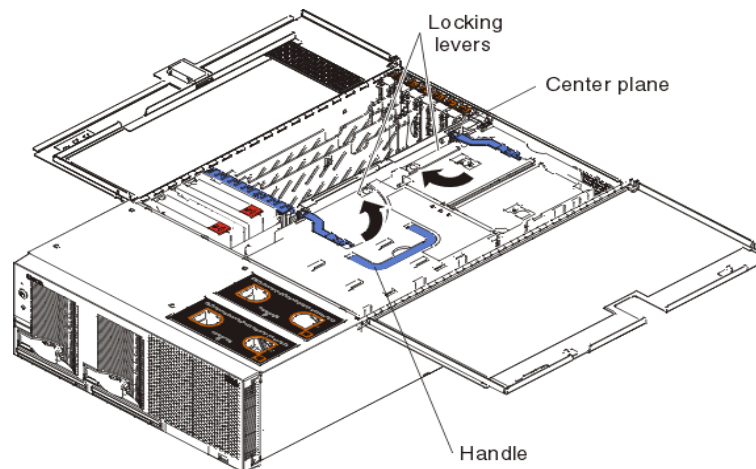
Installing an SMP Expansion Module

Description: You can damage capacitors on the centerplane if you are not careful when you install or remove an SMP Expansion Module (sometimes referred to as a CEC).

2. With the SMP Expansion Module slightly tilted down into the system, align the front edge of the SMP Expansion Module against the side of the top cross member of the chassis; then, align the side wall of the SMP Expansion Module against the inside wall of the chassis.
3. While keeping the SMP Expansion Module in a horizontal plane and still maintaining the tilted alignment described in Step 2, carefully lower the SMP Expansion Module into the chassis; then, gently slide the SMP Expansion Module into the mating connectors.

4. Simultaneously move the locking levers into the locked position.
5. Reinstall the EMC shield on the rear of the server; then, tighten the blue thumbscrew.
6. Reinstall the shipping/retention bracket or brackets.
