Hints, Tips, and Frequently Asked
Questions for the xSeries 440

Quick Reference

Second Edition (October 2002)

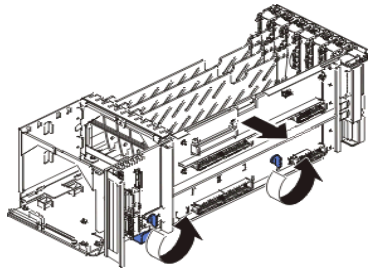
What is the recommended procedure for replacing the centerplane on the xSeries 440 server?

1. Turn off the server.
2. Disconnect all power cords from the back of the server.
3. Remove the PCI brick from the server and place it on a clean work surface.
4. Remove the shipping/retention brackets from the SMP Expansion Modules.

5. Turn the two thumbscrews to release the centerplane; then, carefully lift the centerplane out of its socket.

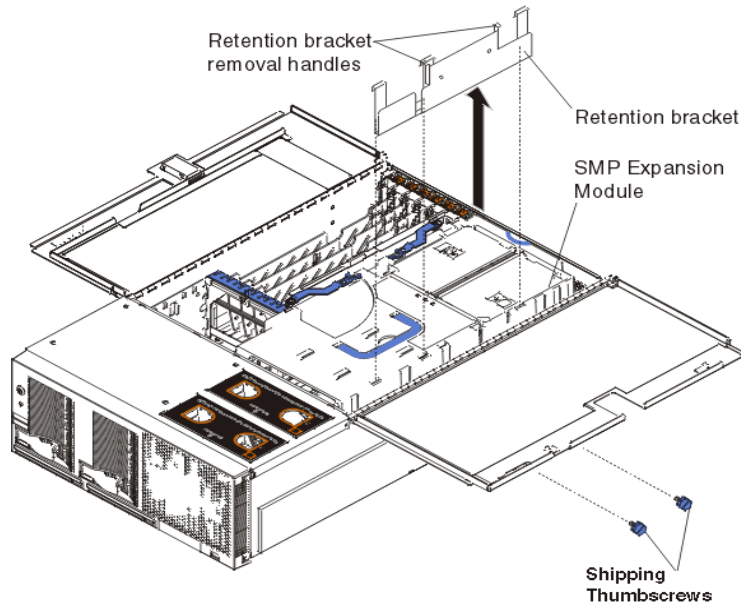
Should the shipping/retention bracket for the SMP Expansion Module be removed after shipment?

The shipping/retention bracket installed between the chassis and the Upper and Lower SMP Expansion Modules (if upper is installed) is required for correct system operation.

Attention: If you remove this bracket, you must replace it.

If a shipping/retention bracket is not available, order FRU part number 24P1283.
